**Excavation of building insulation by carpenter ants (*Camponotus ligniperda*, Hymenoptera; Formicidae)**

**Department of Pest Control**

**Abstract:** A total of 2250 *Camponotus ligniperda* workers and 120 ant larvae were used in 3 experiments investigating the ability of the insulation materials expanded polystyrene (EPS), extruded polystyrene (XPS) and foamglas to withstand excavation and nest construction. The three experiments investigated time until initiation of excavation, level of damage after 5 days of excavation and the effect of elevated temperatures on level of excavation. EPS and XPS was excavated by ants and showed similar properties in terms of ability to withstand initiation and establishment of nests. Foamglas did not experience any nest construction and was significantly less influenced by the ants in terms of weight removed, relative loss of insulation material, area excavated and category nest score. Ants showed a general preference for heated insulation, and heated EPS and XPS blocks experienced significantly higher levels of ant damage compared to cold blocks. As there was no nesting activity in foamglas, no difference between hot and cold insulation could

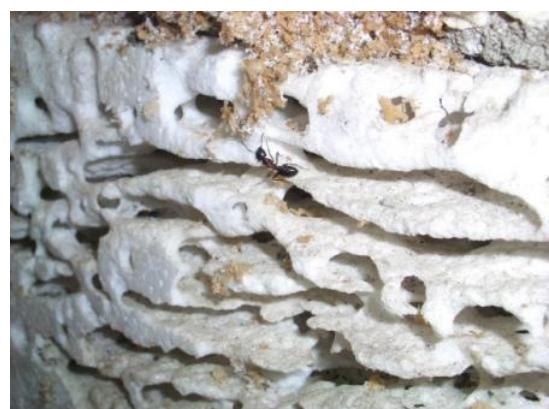
Picture 2: Damage in expanded polystyrene caused by Carpenter ants (*Camponotus ligniperda*)

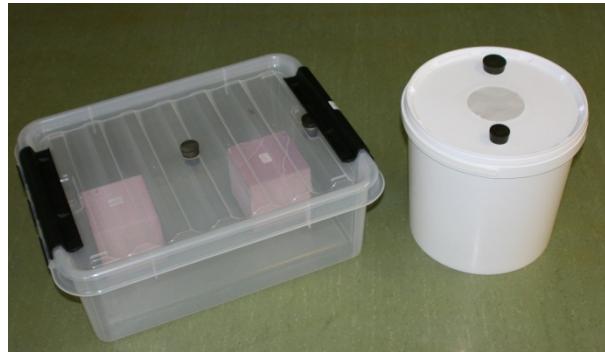
Ant boxes: Tests were performed in 10.8 L white plastic buckets or in transparent rectangular 21.0 L boxes (Picture 3). The lids sealing off these ant boxes had two small openings ( $\phi=3.0$  cm) allowing transfer of ants and visual inspection of activity. These openings were closed by dense rubber corks during the experiment. To allow replacement of air, the center of the bucket lid had a larger opening ( $\phi=8.4$  cm) which was permanently closed by a fine mesh cover. The squared boxes had a narrow gap between the box and the lid to allow ventilation.

**Picture 3:** Boxes used for testing of insulations ability to withstand carpenter ant (*Camponotus ligniperda*) nest excavation

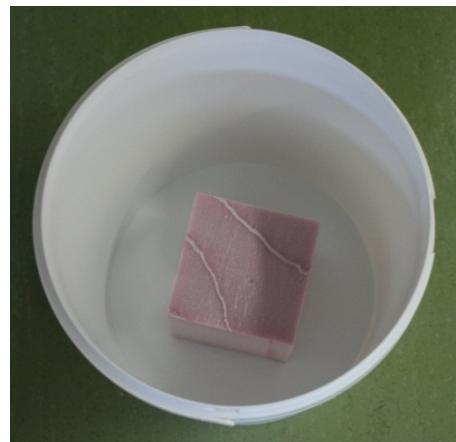
Ten test units (10×10×10cm) of each of the three insulation types were individually assigned to 30 separate buckets (3x10). The insulation blocks were all positioned in the center of the buckets with one side of the test cube horizontally aligned with the bucket bottom (Picture 4). 25 carpenter ants were then added to each bucket and initiation of attack was measured by registration of presence or absence of excavated insulation pieces. The insulation blocks were inspected after 3, 6, 9, 22 and 31 hours. After 31 hours the numbers of living and dead ants were counted and excavation was quantified using visual inspection and category nest score (for category description see “measurement of damage” above).

**Picture 4:** Positioning of insulation blocks in test buckets.

Eight test units (10×10×10cm) of each of the three insulation types were individually assigned to 24 separate buckets (8x3). The insulation blocks were positioned in the center of the buckets with one side of the test cube horizontally aligned with the bucket bottom (Picture 4). 50 carpenter ants were then added to each bucket and the ants were allowed to try to establish themselves in the insulation

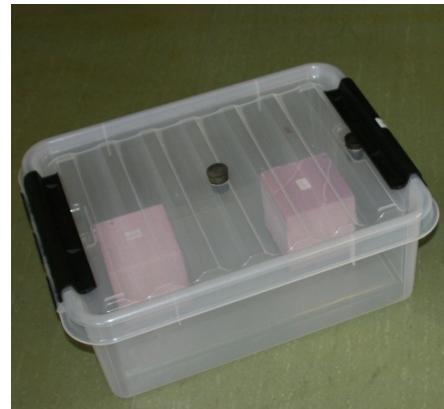
Sixteen test units ( $10 \times 10 \times 10$  cm) of each of the three insulation types were assigned to 24 squared plastic boxes (16/2x3). Two and two test units of the same type were positioned 13 cm apart in the same box (Picture 5). The boxes were then placed on top of electric heating cables and positioned to ensure elevated temperature in only one of the two insulation blocks. The general temperature in the room was kept low by air-condition allowing an approximate temperature gradient of 5 °C between the two insulation blocks. 25 carpenter ant workers were then added to each bucket together with five ant larvae. The ants were allowed to try to establish themselves in the insulation blocks for three days. Three times a day the ants resting on or within 1 cm of the cold and warm insulation blocks were counted. Eventual movement of larvae from the exposed outside to the safety within the insulation block was also scored. After the three days of nest establishment the numbers of living and dead ants were counted, and the damage inflicted on the insulation blocks quantified according area excavated.

**Picture 5:** Positioning of insulation blocks in test boxes.

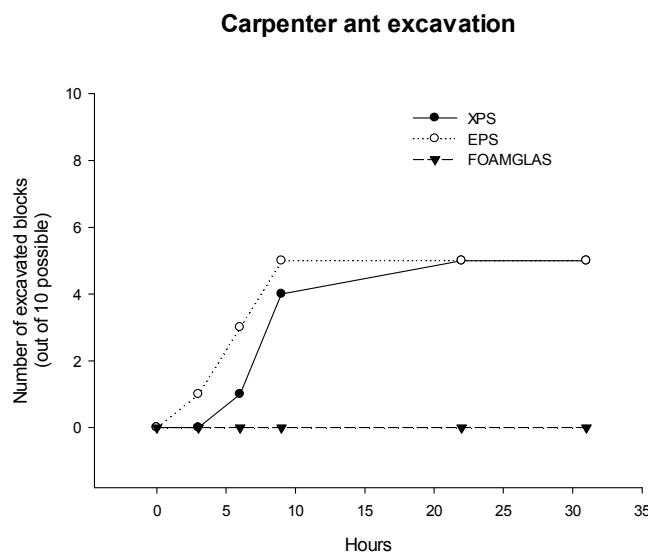
The first sign of excavation appeared after 3 hours in EPS and 6 hours in XPS (Figure 1). Polystyren insulation showed an increase in the number of insulation cubes being excavated by carpenter ants until the 22 hour check. At this time 50 % of both EPS and XPS insulation blocks showed signs of nesting activity, while foamglas appeared undamaged.

**Figure 1:** Carpenter ant excavation in EPS, XPS and Foamglas insulation. The x-axis represent time in hours from release of ants and the y-axis represents the number of blocks (out of 10 possible) showing sign of excavation.

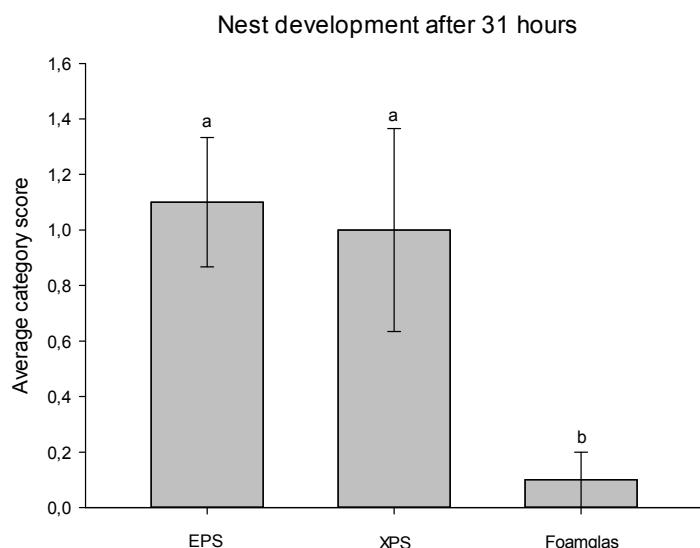
Visual inspection and categorical score of nest structures after 31 hours revealed a significant difference between the three insulation types (ANOVA on ranks:  $H=13.24$ ,  $p<0.001$ ) and the following tukey type comparison identified foamglas to be significantly less excavated compared to EPS and XPS (Figure 2). Both EPS and XPS had nests belonging to the advanced type including chambers and corridors (Picture 6), while foamglas only had one identifiable bite mark in the insulation block.

**Figure 2:** Carpenter ant excavation in EPS, XPS and Foamglas insulation blocks. The average category score  $\pm$  SE is based on a value of 0 for no damage, 1 for initiated excavation with attack of the edges only, 2 for distinctly excavated nest structure with horizontal chambers and corridors and 3 for complex nest structures having both horizontal chambers and horizontally and vertically excavated corridors. 10 blocks of each insulation type was used and damage was scored after 31 hours. Treatments significantly different from each other are denoted by different small letter (a and b).

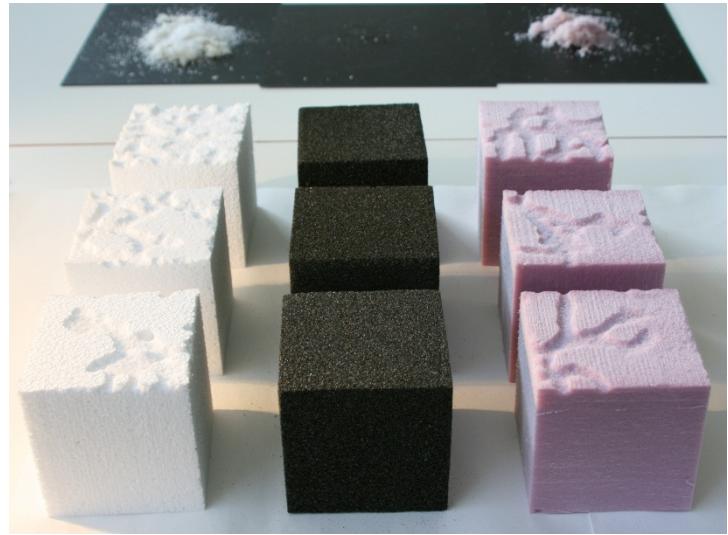
After 5 days of access to the three insulation types, advanced ant nests (Picture 6) were found in 7 out of 8 EPS insulation blocks, in 8 out of 8 XPS insulation blocks and in 0 out of 8 foamglas insulation blocks. Large amounts of small pieces of excavated EPS and XPS were found in connection with the nesting activity, whereas the buckets with the foamglas blocks only showed small amounts of fine dust originating from ant activity and movement on the outer surface of the insulation. The comparison of the weight loss showed a significant difference between the three insulation types both in terms of absolute and relative values (absolute values – ANOVA:  $F=9.279$ ,  $p<0,001$ ; relative values – ANOVA on ranks:  $H=13.242$ ,  $p<0,001$ ). The following tests identified foamglas to be less susceptible to ant excavation compared to EPS and XPS (Figure 3 A and 3 B). Foamglas showed no sign of excavation while EPS and XPS had an average of  $53.7\pm10.4$   $\text{cm}^2$  and  $51.0\pm7.5 \text{ cm}^2$  of the down facing contact surface ( $100 \text{ cm}^2$ ) excavated. Ants never attacked the other 5 sides of the cube. This difference between EPS, XPS and foamglas was significant (ANOVA on ranks:  $H=14.304$ ,  $p<0,001$ ) with equal and higher level of damage on the two polystyrene products (Figure 3 C). The nest category score also showed significant differences between the three insulation products (ANOVA on ranks:  $H=18.027$ ,  $p<0,001$ ) with foamglas being significantly more able to withstand excavation compared to the two polystyrene products (Figure 3 D). EPS had one advanced category 3 nest showing nest structures in both the horizontal and the vertical plane. The remaining 6 nests were horizontal in its arrangement. XPS had 8 category 2 nests with horizontally arranged chambers and corridors only. Foamglas had no nests. The average category score was  $1.9\pm0.3$ ,  $2.0\pm0.0$  and  $0.0\pm0.0$  for EPS, XPS and foamglas, respectively.

**Picture 6:** Visualization of nest excavation. Chambers and corridors were found in EPS and XPS but not in foamglas. Excavated insulation is seen in the background.

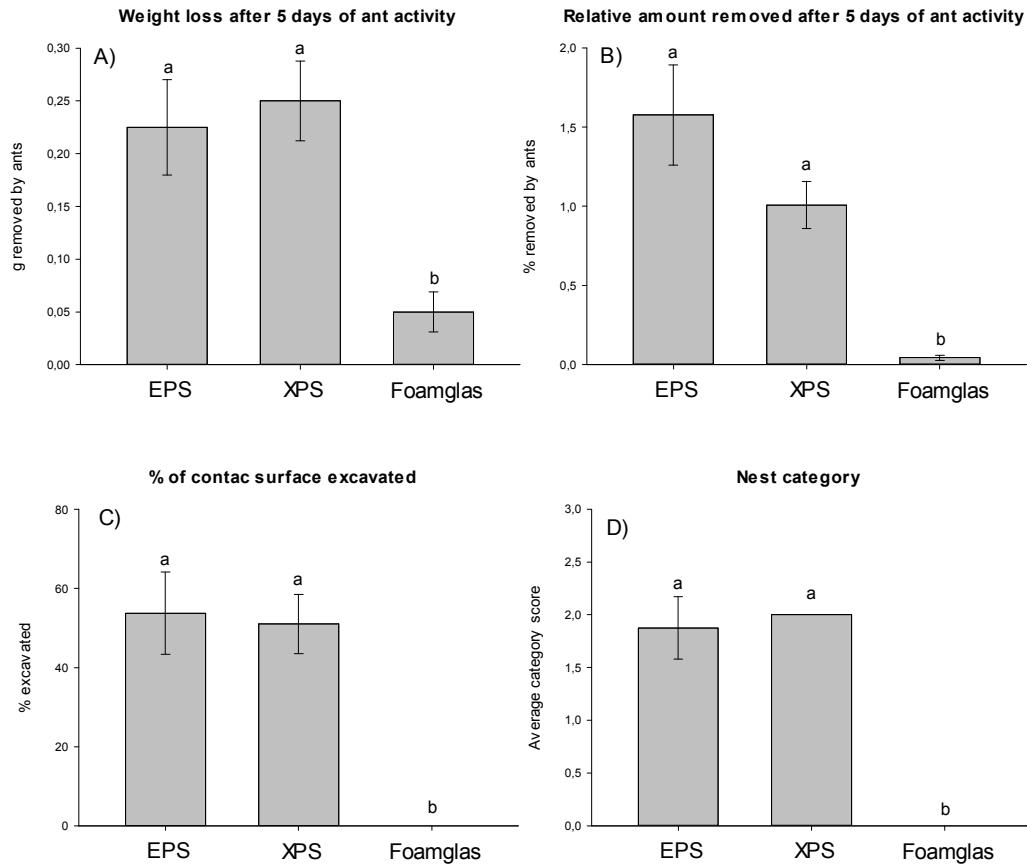
**Figure 3:** Average damage  $\pm$  SE from carpenter ant (*Camponotus ligniperda*) excavation in EPS, XPS and Foamglas insulation blocks. A) Weight loss in grams, B) Relative weight loss in %, C) Area of contact surface excavated and D) Category score based on a value of 0 for no damage, 1 for initiated excavation with attack of the edges only, 2 for distinctly excavated nest structure with horizontal chambers and corridors and 3 for complex nest structures having both horizontal chambers and horizontally and vertically excavated corridors. 8 blocks of each insulation type was used and damage was quantified after 5 days. Treatments significantly different from each other are denoted by different small letter (a and b).

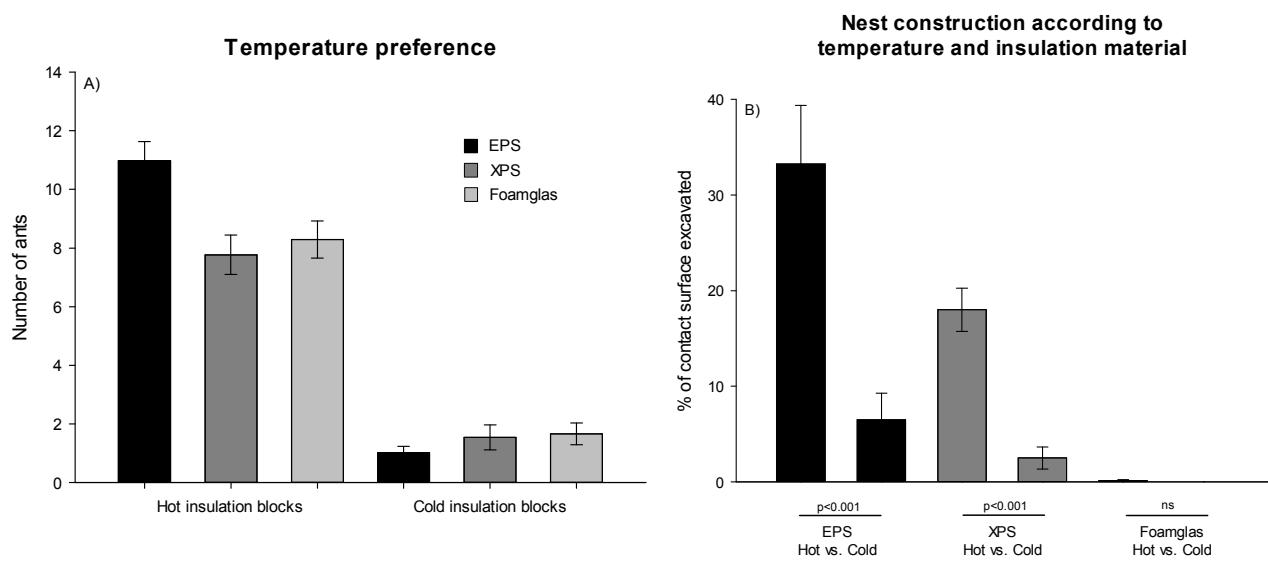
A distinct temperature gradient was established between heated and cool insulation blocks. The cold blocks had an average temperature of  $19.8 \pm 0.3$  °C compared to hot blocks which had an average of  $24.8 \pm 0.6$  °C. The ants showed an overall preference for higher temperatures (Mann-Whitney rank sum test:  $T=29612.3$ ,  $p<0.001$ ) with an average number of  $9.0 \pm 0.3$  resting near the heated insulation blocks compared to  $1.4 \pm 0.2$  near the cold blocks. This heat preference was observed regardless of insulation type in the test boxes (Figure 4 A). The general heat preference also resulted in an increased nesting activity in warm blocks compared to cold blocks for both EPS and XPS, but not for Foamglas (t-test EPS:  $t=26.750$ ,  $p<0.001$ ; t-test XPS:  $t=6.080$ ,  $p<0.001$ ; Mann-Whitney rank sum test Foamglas:  $T=72.000$ ,  $p=0.72$ , Figure 4 B). Larvae were moved from the outside of the blocks to the newly constructed nest within two days of excavation and 15 out of the 16 nests with larvae were located in the hot insulation blocks. Some nesting activity also took place in cold insulation blocks of the EPS and XPS (Figure 4 B).

**Figure 4:** Average  $\pm$  SE A) aggregation and B) damage from carpenter ant (*Camponotus ligniperda*) excavation in EPS, XPS and Foamglas insulation blocks. Damage is quantified according to area of contact surface excavated. 16 blocks of each insulation type was used in a pair vise choise situation with cold ( $19.8 \pm 0.3^\circ\text{C}$ ) and varm ( $24.8 \pm 0.6^\circ\text{C}$ ) blocks as options. Damage was quantified after 3 days. Black bars represent EPS, dark grey represent XPS and light grey represent foamglas.
